Home Inspection Report

Sample Report, Murray , KY 42071

Friday May 31, 2019

5312019-K1

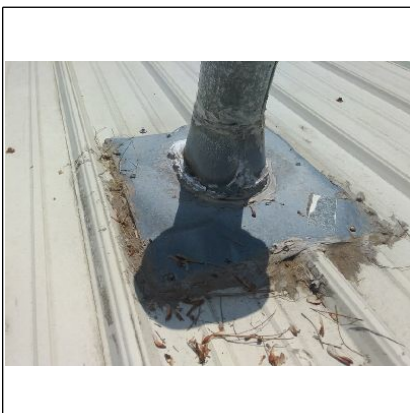
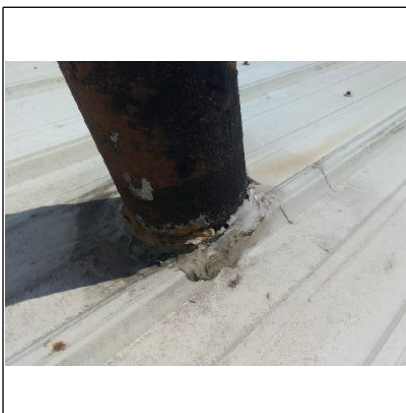
Condition ☐ Satisfactory ☒ Marginal ☐ Poor

Comments 1. Recommend sealing open areas around plumbing vents.

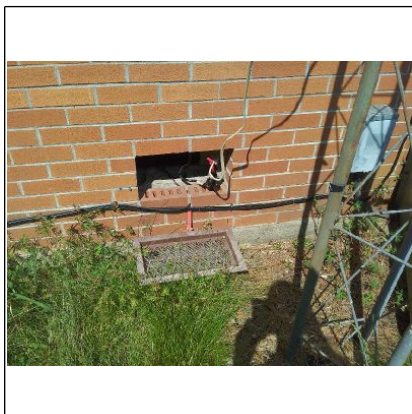
Comments 1. Wiring connection exposed.

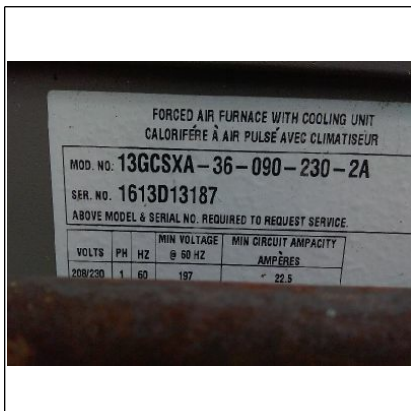
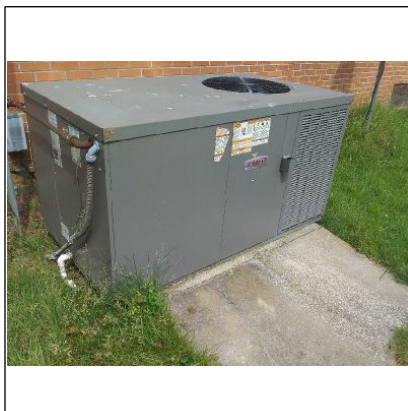
Outside Disconnect ☒ Yes ☐ No Maximum fuse/breaker rating (amps): 35 Fuses/Breakers installed (amps): 40
☒ Improperly sized fuses/breakers

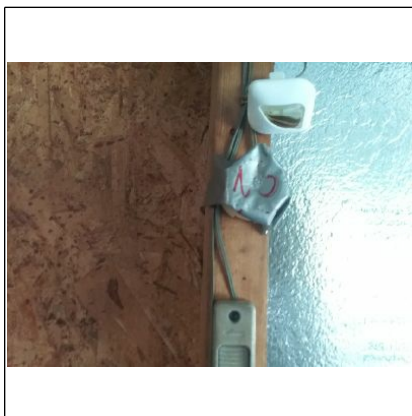
1. First two doors are operating.
2. 3rd door not tested due to switch being taped in off position.

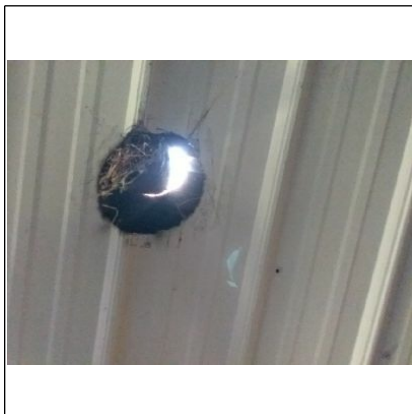
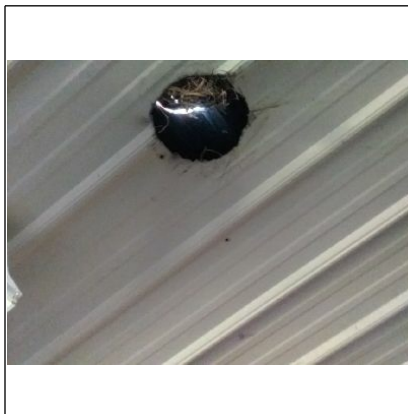
1. Recommend sealing around vent pipe.
2. Roof appears to be leaking at vent pipe penetration point.

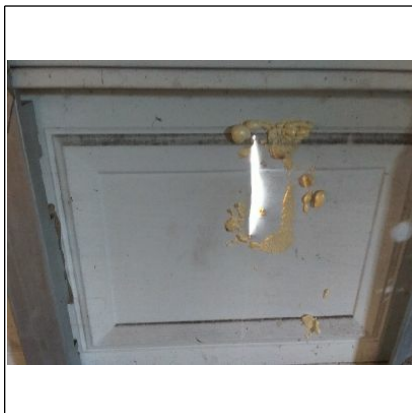
Comments 1. Third door is damaged.

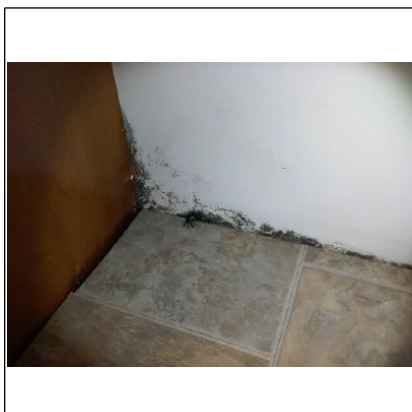
Comments 1. Water supply line to refrigerator leaking.
2. Mold/mildew on wall and floor at refrigerator location.

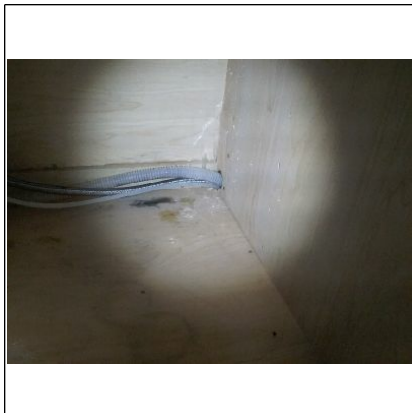
Comments 1. Open ground receptacle near water source.
 2. Dishwasher drain line is leaking.

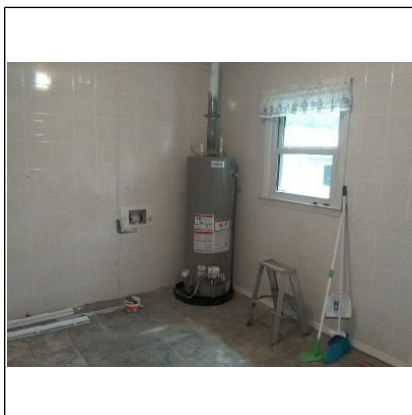
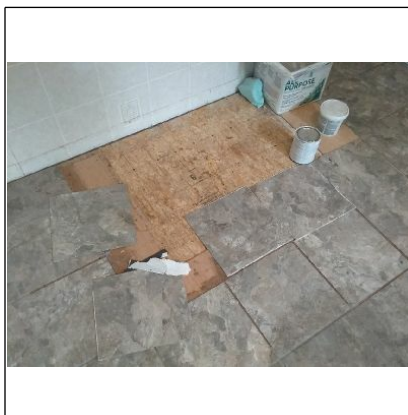
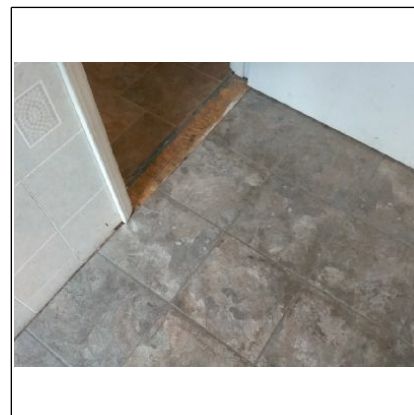
Comments 1. Floor appears to be unfinished in areas.

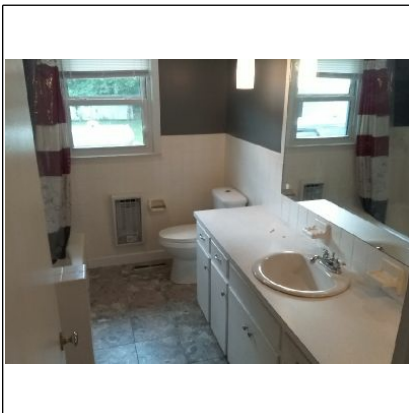
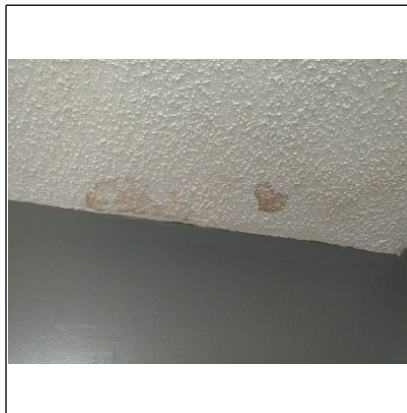
Comments 1. Open ground receptacle near water source.
2. Moisture stains on ceiling.

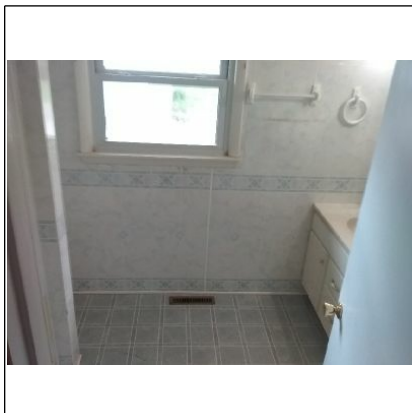
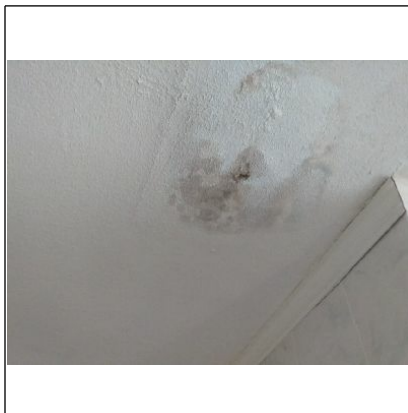
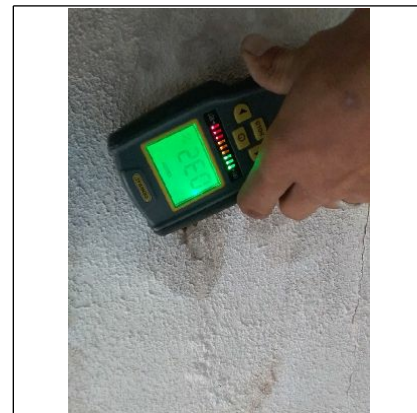
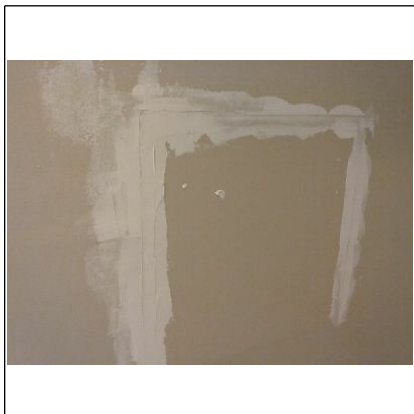
1. Moisture stain on ceiling.
2. Mold/mildew stains on ceiling.
3. Open ground receptacle near water source.
4. Moisture stains on ceiling of hall closet.

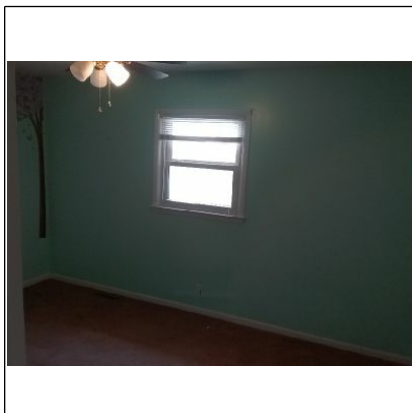
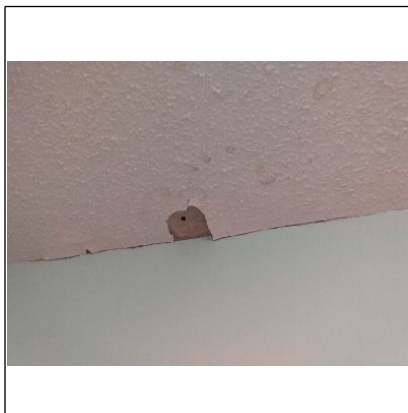
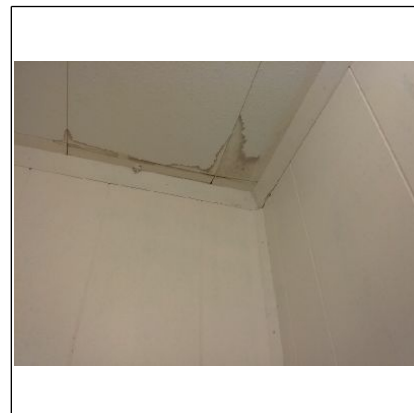
Comments 1. Moisture stains on ceiling.

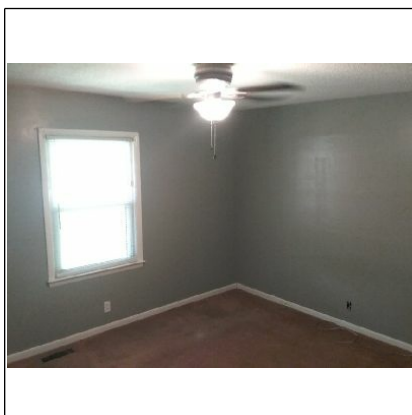
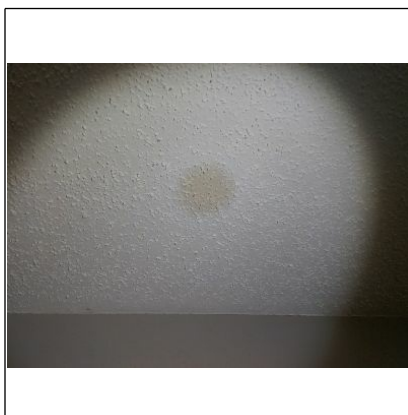
Comments 1. Moisture stains on ceiling.

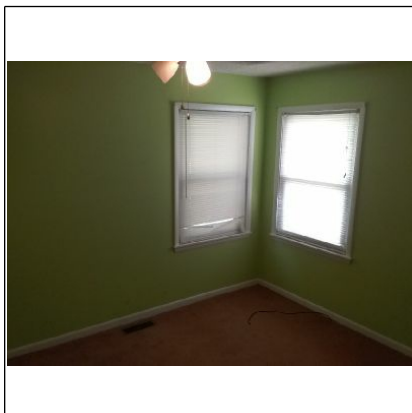
Doors ☐ None ☐ Satisfactory ☐ Marginal ☐ Poor ☐ Cracked glass ☒ Broken/Missing hardware

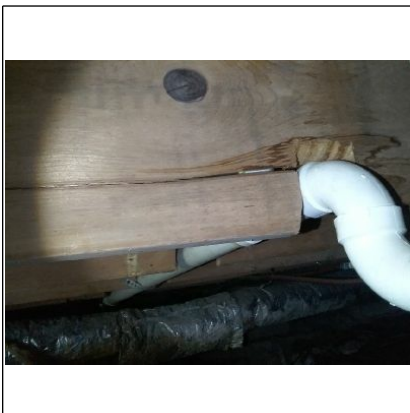
Comments 1. Multiple floor joist altered for plumbing.

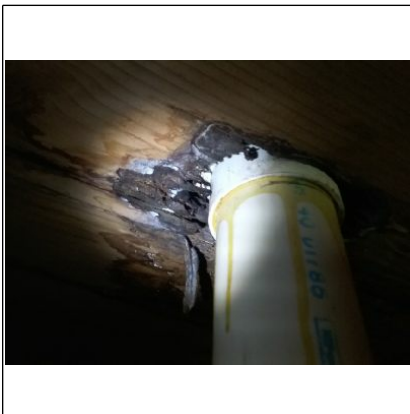
Subfloor

Condition ☒ Deteriorated in Areas

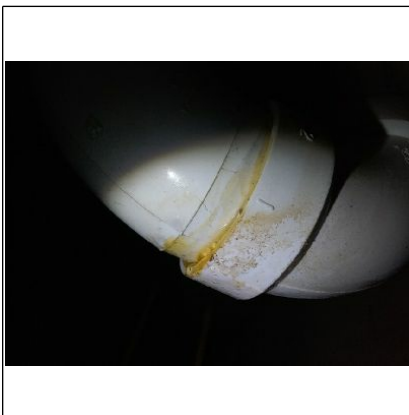
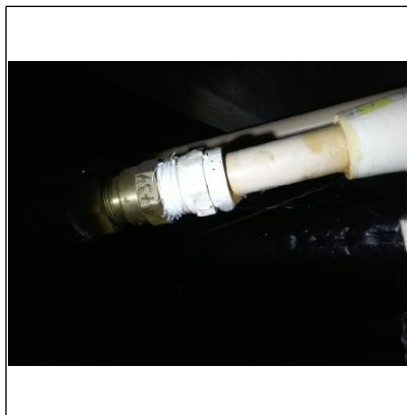
Comments 1. Supply line under bathroom 2 leaking.
2. Drain under bathroom 2 leaking.

Pipes Supply/Drain ☐ Corroded ☒ Leaking ☐ Valves broken/missing ☐ Dissimilar metal Cross connection: ☐ Yes
☐ No ☐ Safety Hazard ☒ Recommend repair ☐ Recommend a dielectric union ☐ Satisfactory

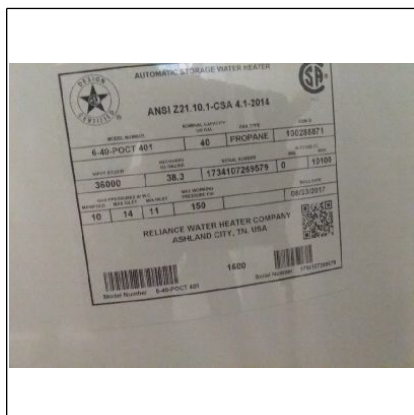
Comments 1. Unable to operate water heater due to gas being shut off.

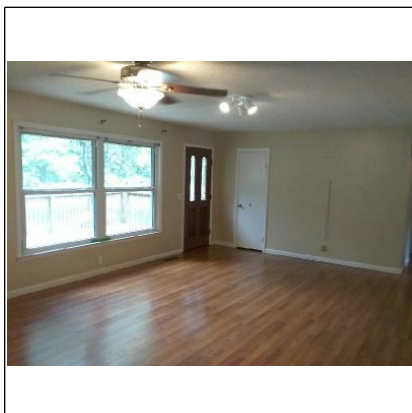
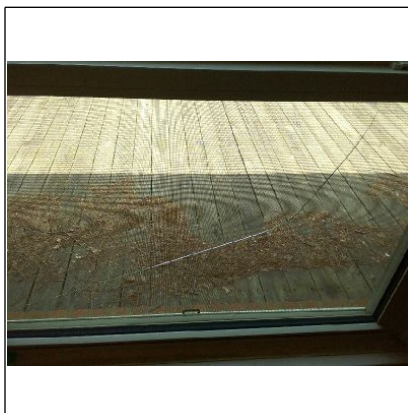
Comments 1. Window is cracked.
2. Floors sloped in areas.

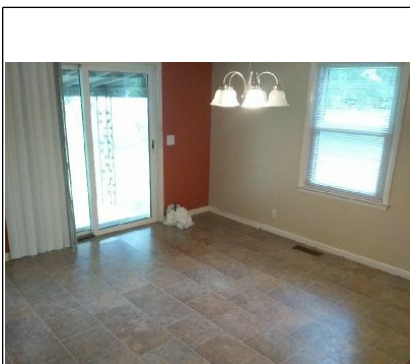
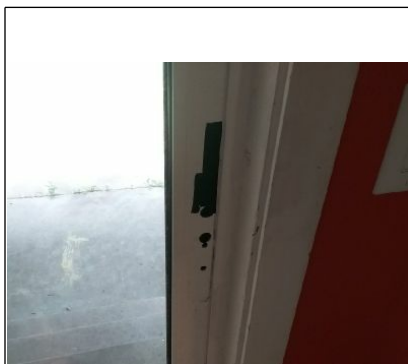
Comments 1. Sliding glass door has missing hardware.
