Home Inspection Report

Sample Report, Murray , KY 42071

Friday May 31, 2019

5312019-K1

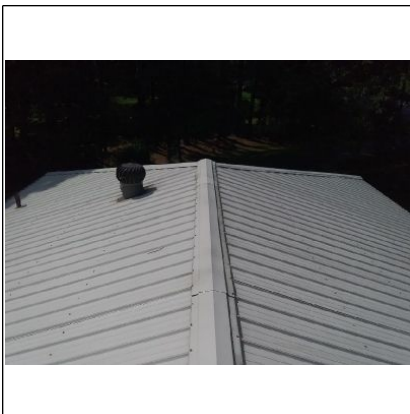
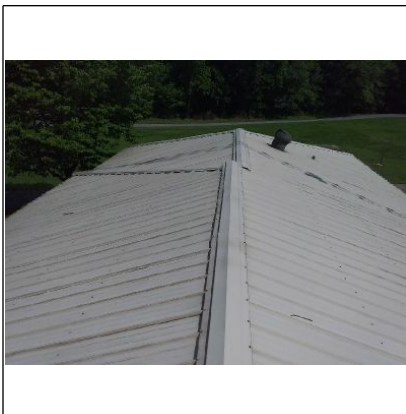
Roof #1 ☒ Satisfactory ☐ Marginal ☐ Poor ☐ Curling ☐ Cracking ☐ Ponding ☐ Burn Spots
☐ Broken/Loose Tiles/Shingles ☐ Nail popping ☐ Granules missing ☐ Alligating ☐ Blistering
☐ Missing Tabs/Shingles/Tiles ☐ Moss buildup ☐ Exposed felt ☐ Cupping
☐ Incomplete/Improper Nailing ☐ Recommend roofer evaluate ☐ Evidence of Leakage
